WM-20230816 Porl

16<sup>th</sup> August 2023 - 11:20am

Simon D Morgan

War Memorial - Dunster Steep, Porlock.

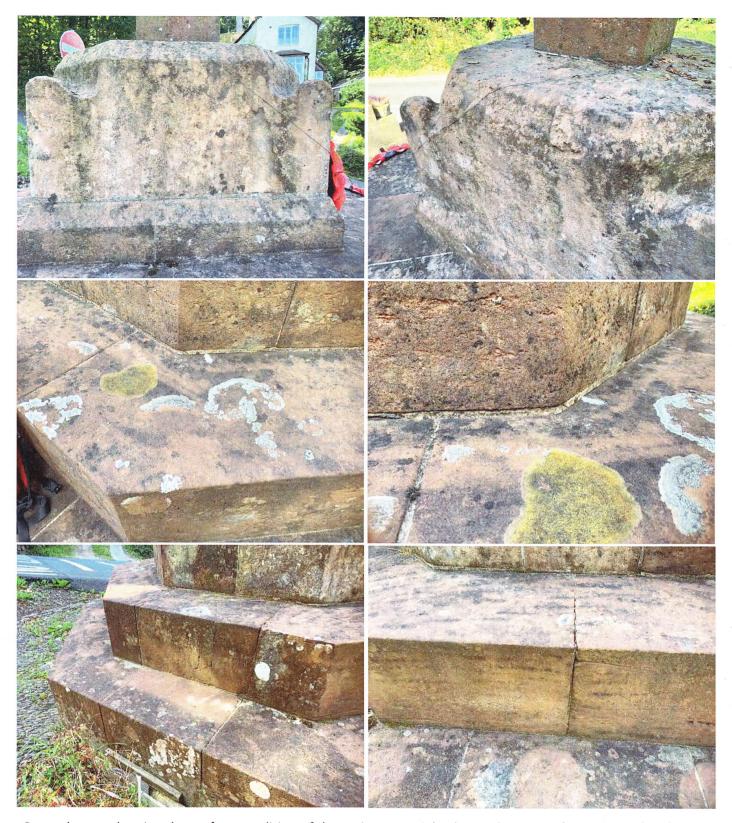
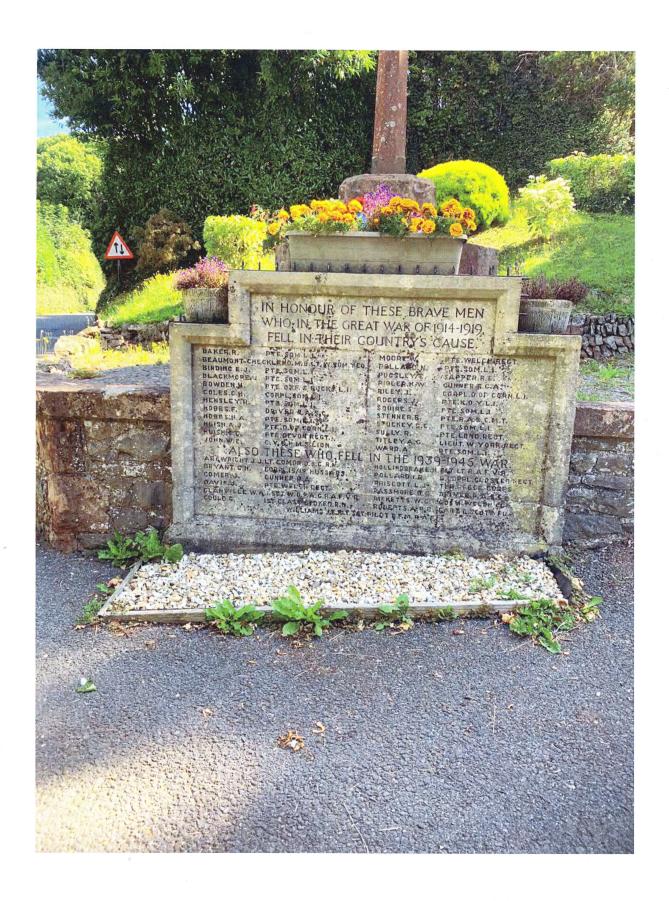
The memorial surfaces have weathered and appear to have carbon deposits and biological growths caused by the close proximity of the busy roads and plentiful negational growth. There was also observed a significant build-up of bird-droppings on the upper Cross sections and the top of the upper base.

General areas showing the surface condition of the main memorial - clear indications of vegetational and biological growths (lichens, algae etc) as well as pollutants and general air-born debris.

The memorial would therefore greatly benefit from a full professional cleaning and we would recommend, in line with the War Memorials Trusts "best conservation practice" careful conservational-restorative cleaning to the more delicate and detailed carved areas should be carried out by delicate

The other main areas of the memorial should be cleaned with careful and professional use of the DOFF System method of cleaning technique which will remove the biological growths.

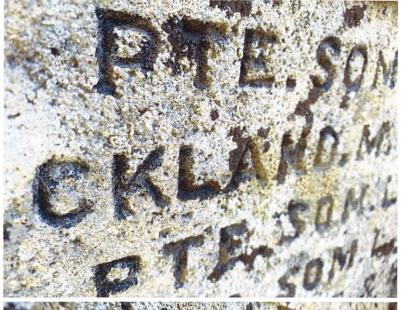
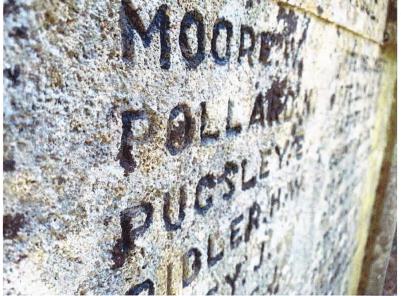
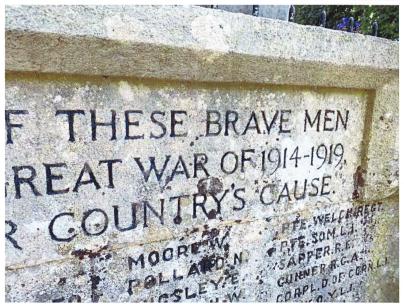
The front limestone inscription section has indications of overly aggressive previous cleaning techniques having been applied. The softer elements of the limestone structure have been eroded possibly by high-pressure cleaning with a "sugary" texture remaining which encourages more rapid return of biological growths and traps more air-born pollutants and debris.

The inscription panels are hand-engraved with v-cut letters which have then been inlaid with black enamel to ensure that they remain legible. The black enamel has begun to weather away and flake in most areas.

Porlock War Memorial - Dunster Steep Site Visit Photographs - 16 August 2023 Inscription panel - showing pitted signs of accelerated erosion - but good depth to inscription remains and still sharp enough to be able to be re-painted with specialist black stone enamel but would need to be carefully applied by hand by a skilled craftsman to help minimise distortion to letter-shaps caused by the erosion to the surface generally.

On close on-site inspection, although the surface of the engraved stone has been eroded and become "sugary", the characters remain relatively respectfully deep and sharp and do not, at this time, require deepening and re-sharpening. However, they would significantly benefit from having them re-black-enamelled by careful hand-application from a skilled craftsman following the recommended cleaning process.

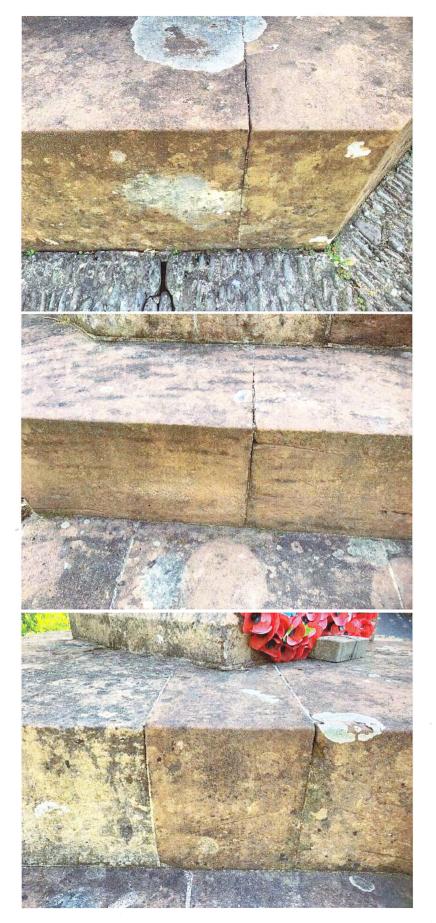
You will note from the photographs enclosed, that there are several areas where the joints of the main memorial and the inscription panel have failed or have become defective.

Should the missing/failing pointing not be addressed in the short-term, then this will lead to a rapid deterioration of the memorial and masonry generally allowing water penetration which can lead also to frost damage, as well as allowing vegetation to begin growing within the missing mortar areas. There are already several areas where vegetative growth has begun and needs to be arrested before it causes significant problems with the structural integrity of the memorial.

Examples of missing &/or defective mortar joint pointing which will need replacing.

We would therefore strongly recommend that following the cleaning, all of the existing mortar is carefully checked and tested after the memorial has been cleaned. Then any missing, loose/open and defective pointing will need to be carefully hand-raked out by hand using a club hammer and relevant chisels or for finer joints a thin stainless-steel blade or hook.

The joints should then be re-pointed using a lime-based mortar closely matched in constitution, consistency, colour and texture to the original mortar mix.

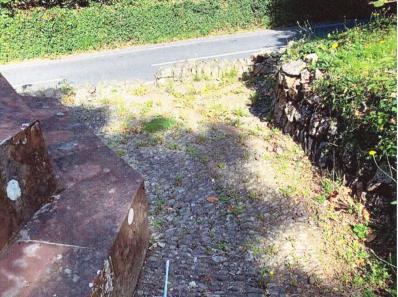
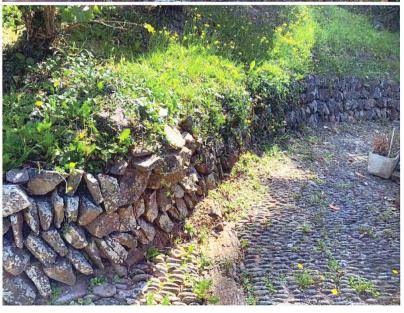
The cobbled area surrounding the main memorial and the coping of the surrounding walling together with some areas of the boundary walling have also experienced mortar failing with open and defective joints which have quite significant vegetational growth beginning to take hold. We would strongly recommend that the vegetational growths are all removed and the joints re-pointed in these areas as well to secure these sections.

Stone-paved area surrounding the memorial requires weed-removal and then re-pointing to reduce further vegetational growth which will accelerate deterioration of paved area.

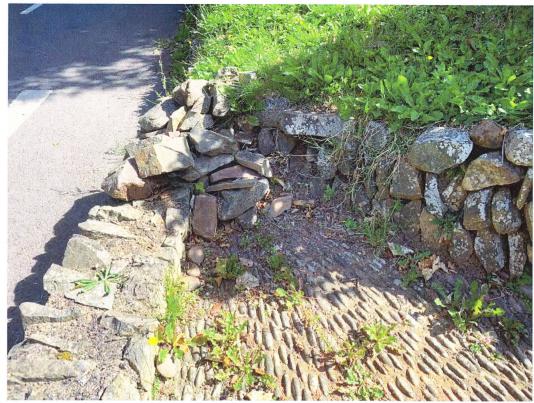
The dry-stone walling section in the top North-West corner has experienced a partial collapse. This requires rebuilding and re-tying in with the main wall to ensure this deterioration does not continue.

North-West corner of the walled area has suffered a partial collapse and requires re-building.

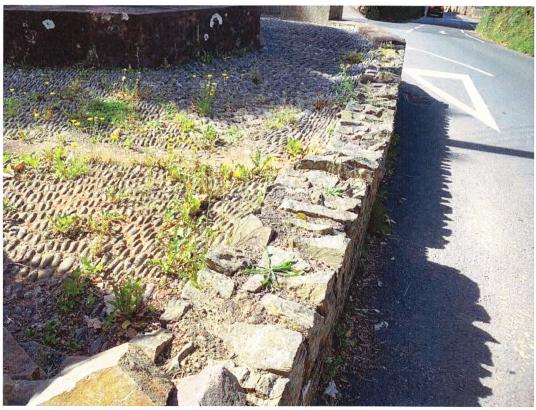
The remaining areas of walling require vegetation removal and re-pointing as necessary to prevent further deterioration.

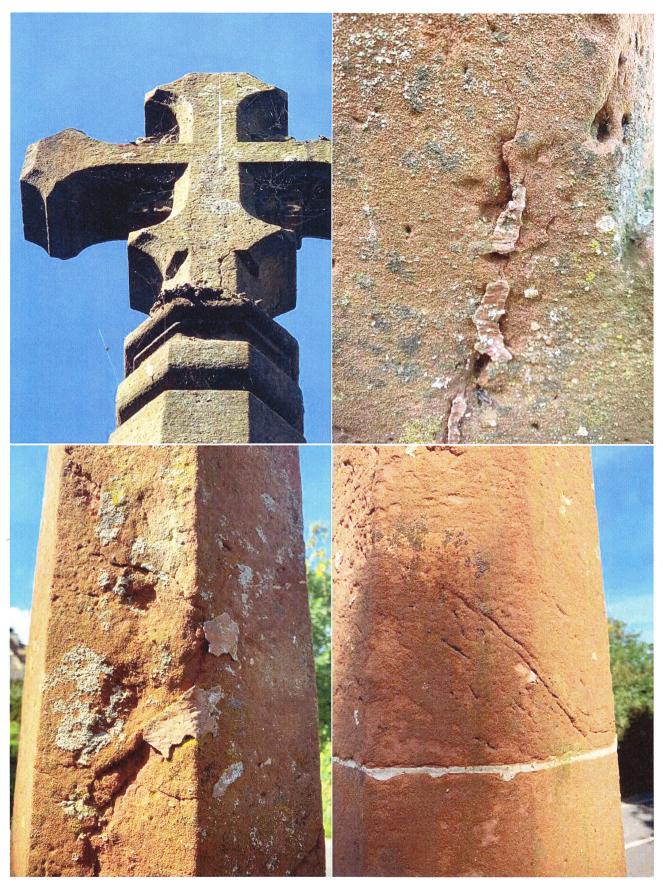
The red-sandstone has some areas where fissures and cracks have appeared as well as a few areas which appear to have previously repaired but these repairs have now failed.

Defects, fissures and faults in some areas of masonry including evidence of previous repairs that have now failed. These need repairing to prevent further deterioration.

We would therefore strongly recommend that the old repairs are attended to and the fissures are filled with lime-based, colour matched consolidation material to help reduce the moisture ingress which if left unattended will lead to an accelerated deterioration by "freeze-thaw" damage and/or vegetational growth.

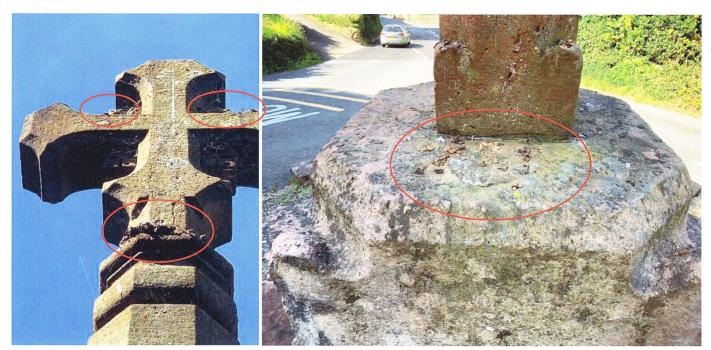
Secondly, it was observed, as stated above, that there is a build-up of bird-droppings on the upper Cross sections and on the top base. This can be quite corrosive and damaging if left unattended. We would recommend that consideration be given to setting a subtle bird-spike section to the apex of the Cross to discourage birds from perching and creating this problem.

General "House-Keeping" recommendation: - birds are currently perching on the top of the Cross - they are then depositing droppings on the ledge and top of the bases. These droppings are not only unsightly and a potential health-hazard - they can, by their chemical composition, be quite damaging to the masonry if left on the surface for prolonged periods.

Consideration should be given to the fitting of anti-bird spikes to the top of the Cross to discourage perching.

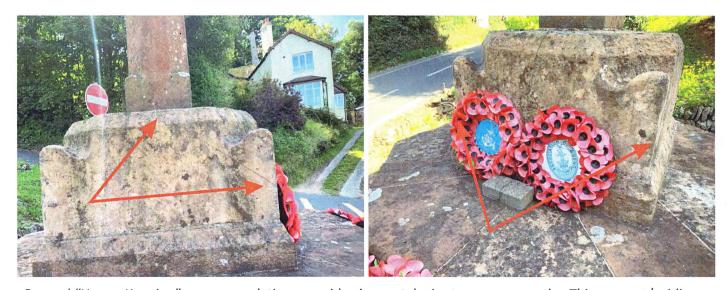
This wire may cause localised staining if and when it begins to deteriorate and rust. In addition to this the movement of the wreathes in wind or from vehicle draft etc can cause the wire to more almost in a sawing-action. Over a prolonged period this may cause damage or grooving to the masonry surfaces that it is in contact with.

<u>General "House-Keeping" recommendation</u>: - avoid using metal wire to secure wreaths. This can rust/oxidise and leave stains but also it will, over time, erode away the masonry where the wire is touching the stone especially with small movements caused by wind and passing traffic etc.

We would recommend that you consider using an alternative method of wreath attachment. We have for many War Memorial, supplied and fitted a tensioned stainless steel wire system. This consists of two stainless steel supports that are secured into the mortar joints rather than drill the masonry, which then have a taunt stainless steel wire suspended between them. This can then have individual wreaths secured to the this stainless steel wire to prevent any damage being caused to the masonry (please see over-leaf for example).

Consideration should be given to fitting a more permanent system - such as a Stainless Steel Wire System, that can be fitted on the memorial using the mortar joints for fixing areas (rather than drilling the masonry for fixings) - this can then have the wreaths attached to the wire to prevent the need for the potentially damaging wire currently being used.

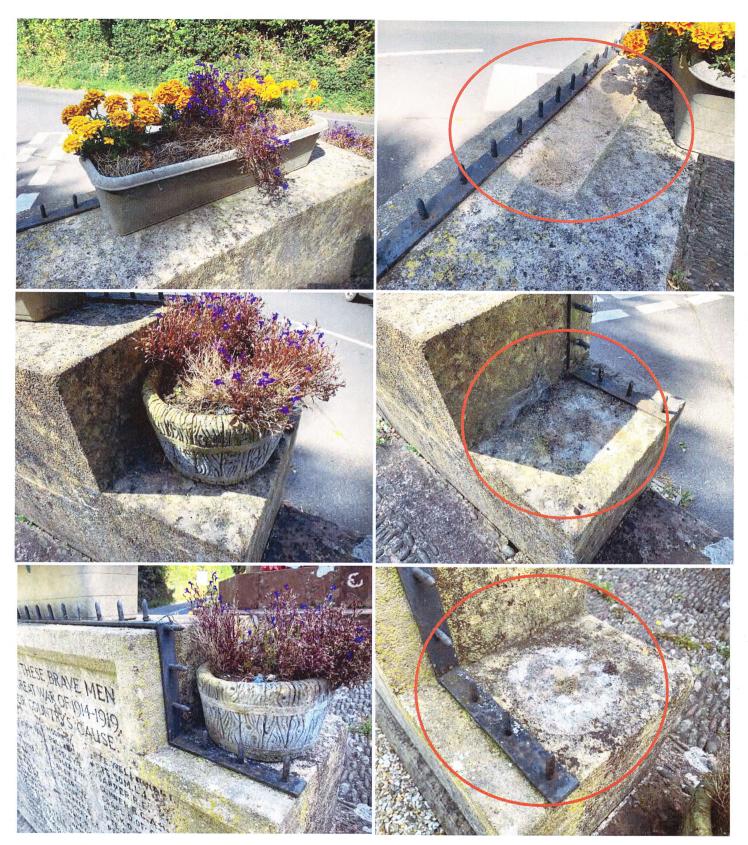
Firstly, it was observed that a number of flower-planters are rested directly on the masonry surfaces – three such planters were on the more vulnerable limestone of the front inscription panel structure. These create and also trap moisture which it then absorbed and trapped within the surface of the stone. This trapped moisture encourages biological growths (algae and similar) and insect infestations. Ideally the stone should be left to breath and have nothing resting on it – however, if you do desire to maintain this sort of planter on the surfaces then we would recommend that they are placed on small risers that will allow airflow.

General "House-Keeping" recommendation: - avoid placing flower pots directly on to the masonry. The moisture that this creates and traps along with any staining elements, can discolour the masonry below and accelerate the deterioration of the masonry as it is kept in an almost permanent moist/damp condition. Consideration should be given to preferably re-locating these on alternative surfaces or setting them to small risers to increase air-flow.

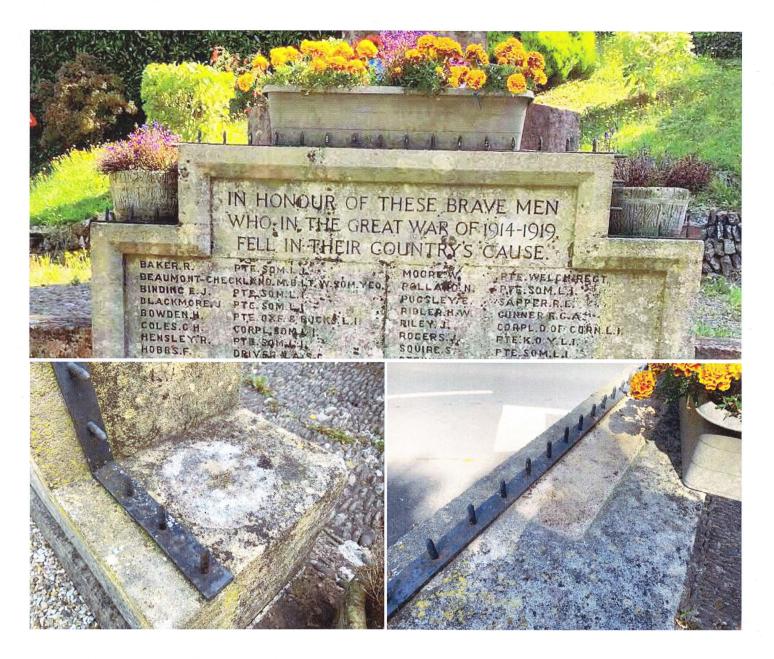
The black enamel coating on the metallic spike feature on the top of the inscription sections of the memorial have begun to flake and fail and the metal has oxidised (rusted) in a lot of areas. We would recommend that they are stripped of any remnants of the existing failing and flaking enamel, prior to be treated with two coats of zinc-based primer, one coat of micaceous iron-oxide (anti-rust) and then re-painting using two coats of specialist, high-grade gloss, external metal enamel paint.

<u>General "House-Keeping" recommendation</u>: - the enamel paint surface on the iron spike feature on the main inscription panel has begun to flake and fail - this has lead to oxidisation (rust) of the surface and if left unattended the rust could irreparably stain the limestone.

Consideration should be given to removing all remnants of flaking/failed enamel paint before treating with an anti-oxidize coating and then re-applying a black gloss finish enamel paint (external grade).
