WM-20230816 Porl

16<sup>th</sup> August 2023 - 11:20am

Simon D Morgan

War Memorial - Dunster Steep, Porlock.

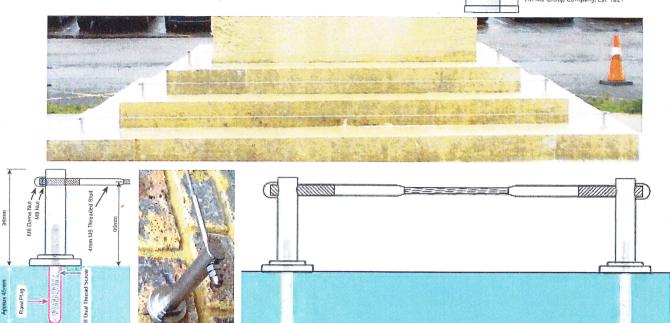
Thirdly, it was observed that the Remembrance Day Wreaths are attached to a mid-steel wire which is wrapped around the upper base of the Cross.

This wire may cause localised staining if and when it begins to deteriorate and rust. In addition to this the movement of the wreathes in wind or from vehicle draft etc can cause the wire to more almost in a sawing-action. Over a prolonged period this may cause damage or grooving to the masonry surfaces that it is in contact with.

Example of Tensioned Stainless Steel Cable System for Wreath Attachment.

We would recommend that you consider using an alternative method of wreath attachment. We have for many War Memorial, supplied and fitted a tensioned stainless steel wire system. This consists of two stainless steel supports that are secured into the mortar joints rather than drill the masonry, which then have a taunt stainless steel wire suspended between them. This can then have individual wreaths secured to the this stainless steel wire to prevent any damage being caused to the masonry (please see over-leaf for example).

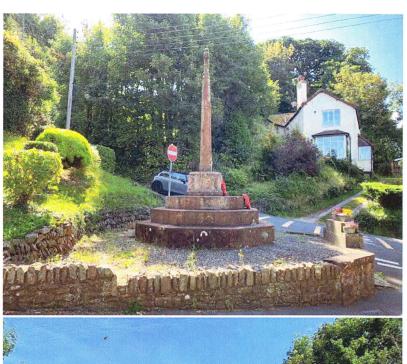
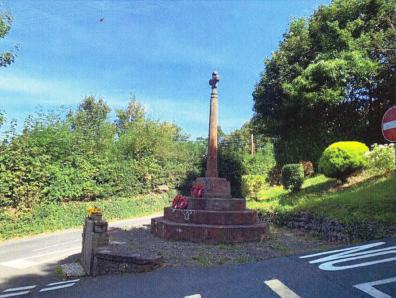
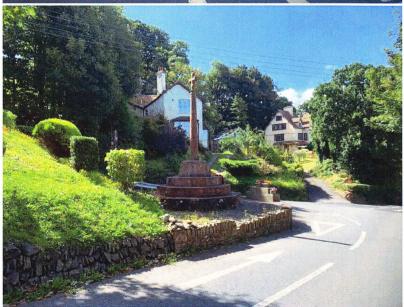
Porlock War Memorial - Dunster Steep Site Visit Photographs - 16 August 2023

General areas showing the surface condition of the main memorial - clear indications of vegetational and biological growths (lichens, algae etc) as well as pollutants and general air-born debris.

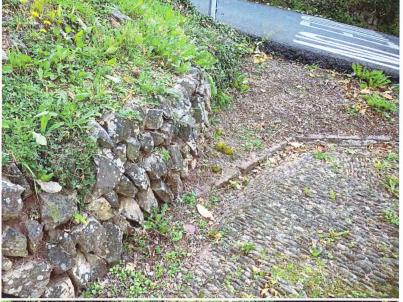
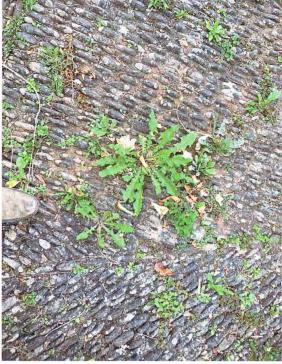
Examples of missing &/or defective mortar joint pointing which will need replacing.
