# PORLOCK PARISH COUNCIL

## REPORT – BOUNDARY FENCE TO POLLARDS COURT HIGH BANK CAR PARK

**Date:** 12 September 2025

**Location:** High Bank Car Park

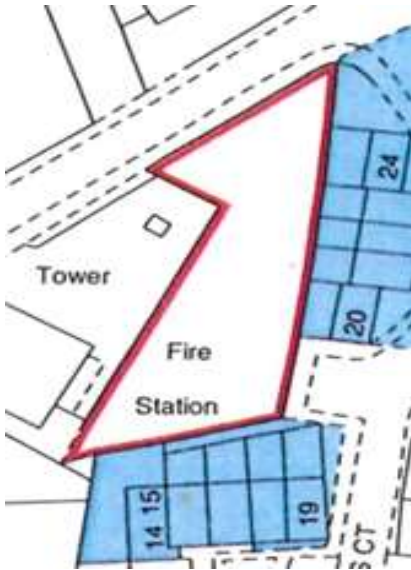
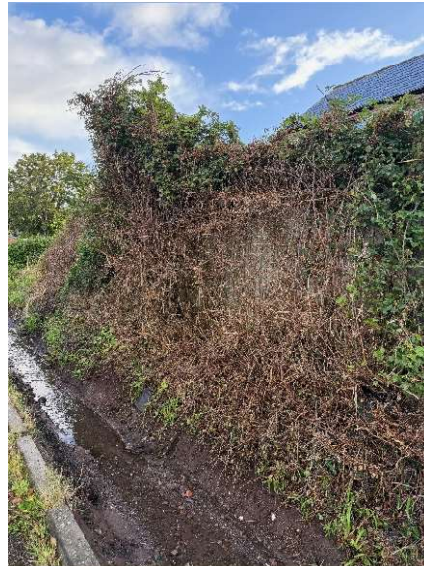
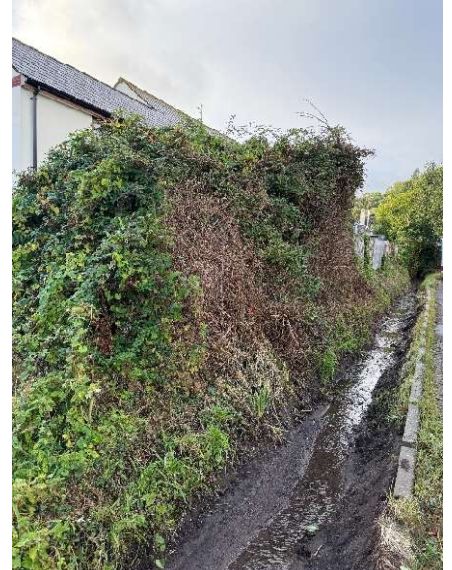
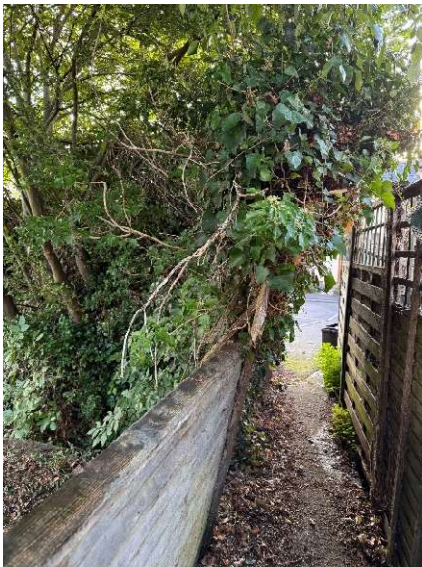
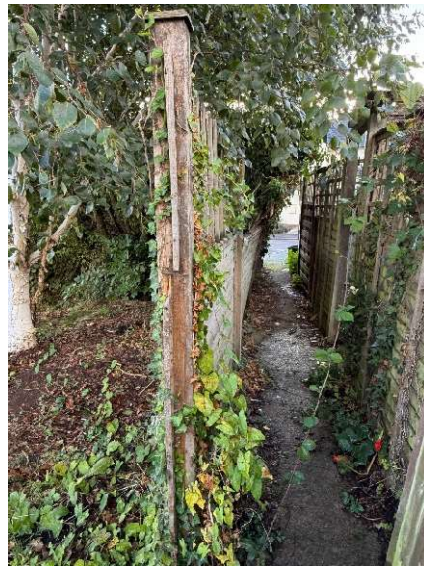
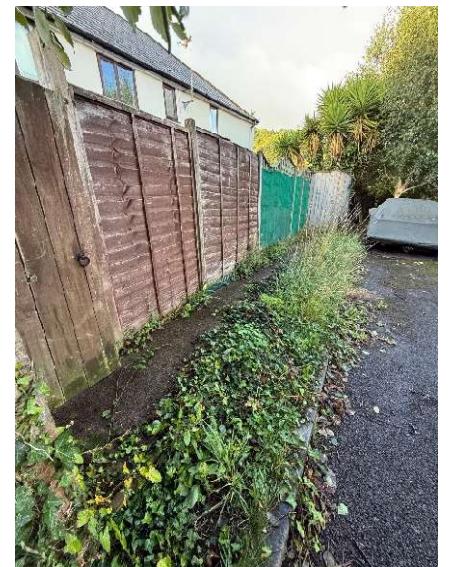
- Historic title deed boundary ownership documents.
- Maintenance history and budget records for High Bank Car Park.
- **Image references:**

- The remaining two fence posts have failed, compromising the structural integrity of the fence.
- The fencing is rotting due to dense mountain ivy growth.
- The fence serves a critical safety function by protecting the stream edge near the car park and pathway.
- Immediate action is required to prevent further deterioration and ensure public safety.

- Remove remaining two failed fence posts and panels.
- Use treated timber for durability and ensure secure anchoring to support the existing structure.

- Install a new wood railing to the length of the path
- Ensure proper alignment and secure fittings to restore safety and boundary definition.

- Remove or the vegetation covering the fencing.
- Implement ongoing vegetation control to prevent future rot and allow for regular maintenance inspections.
